Hursley Infiltration Plan

Appendix A – work complete and planned

from
**Southern
Water**

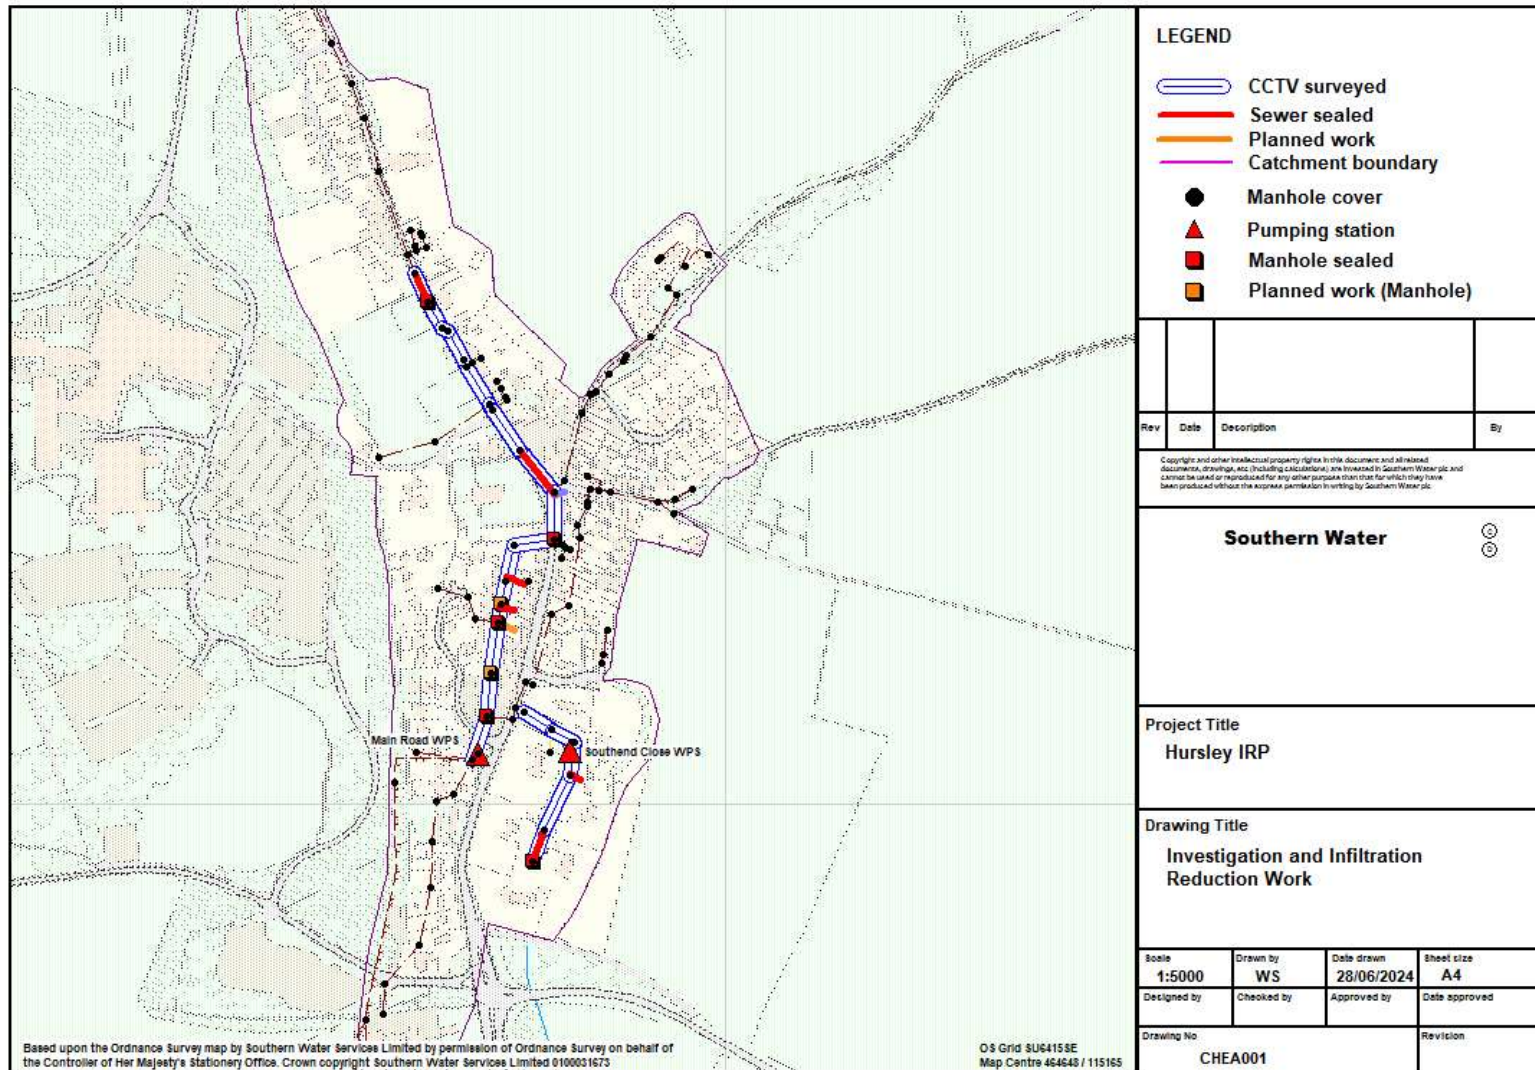
Sealing completed

Work type	
Length surveyed	1.14km
Length with no work required	0.97km
Length sealed	0.15km
Length to be sealed	0.02km
Manholes sealed	5
Manholes to be sealed	2

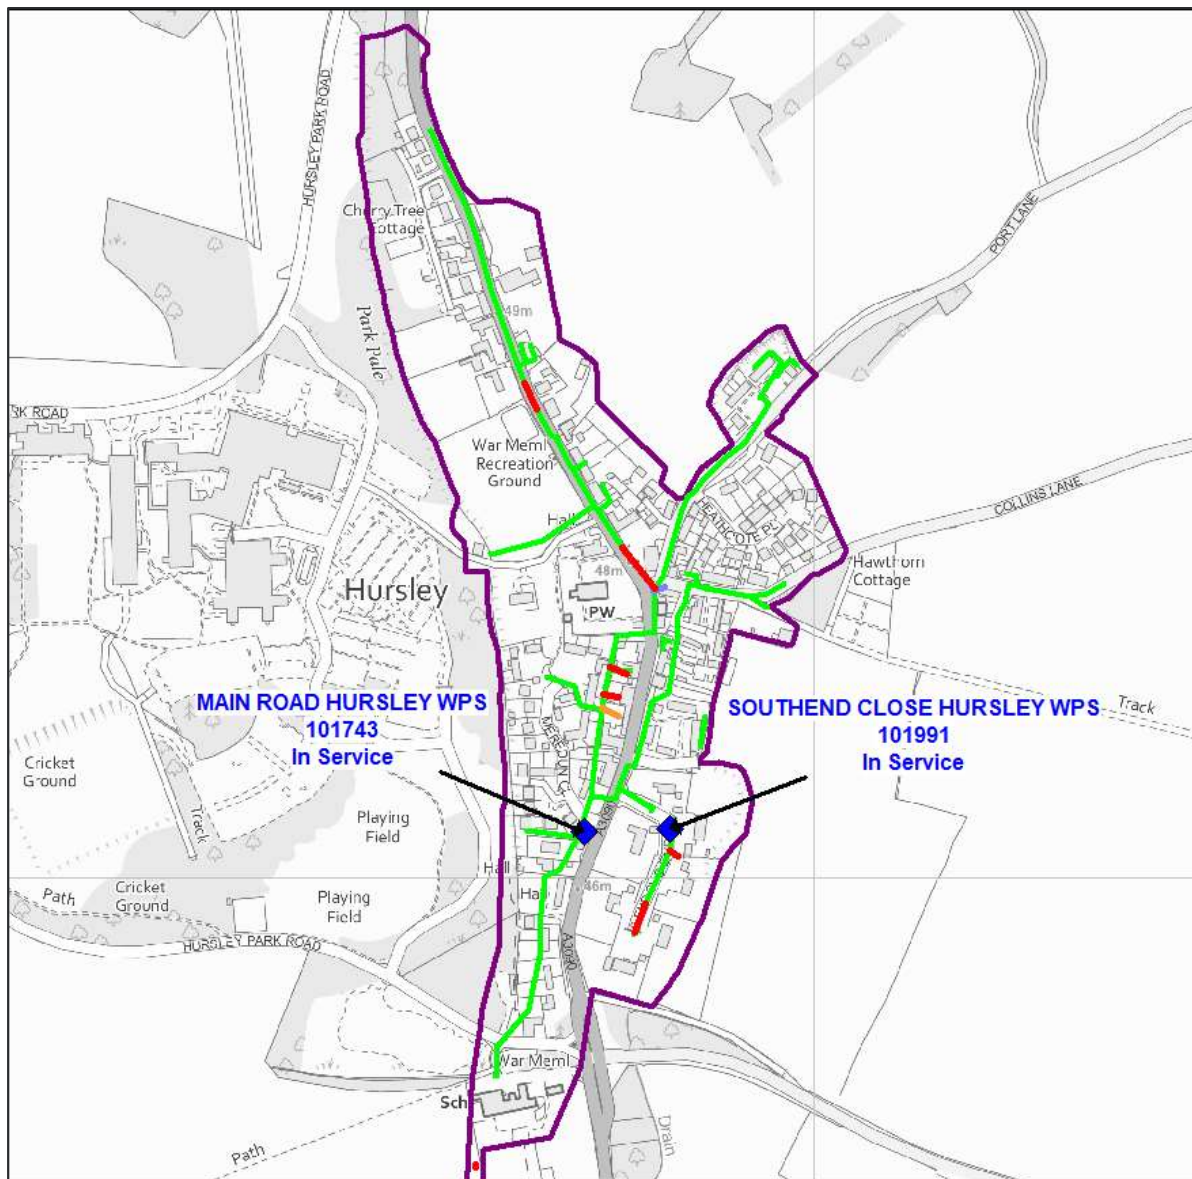
Electroscan surveys

- Red – Sewers surveyed and sealed (276.6m)
- Green – Sewers electroscan surveyed (2.3km)

Note – sewers shown as surveyed by cctv or electroscan (Green line) with no corresponding sealing work have been determined to not require rehabilitation. The use of storm harvester data will be used at some point in the future to target inspections and find infiltration
