Sidlesham Infiltration Plan

Appendix A – Status of Planned Actions August 2025

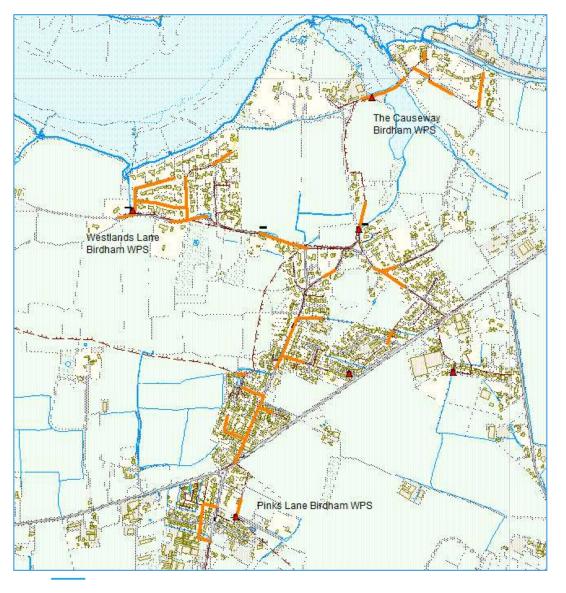
Birdham Sewer Sealing

Sewers sealed

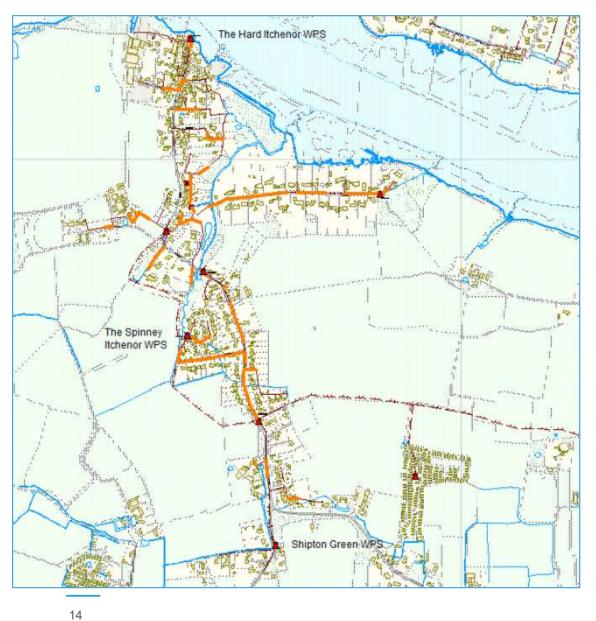
Itchenor Sewer Sealing

Sewers sealed
