Winchelsea Beach Infiltration Plan

Appendix A – Status of Planned Actions - August 2025

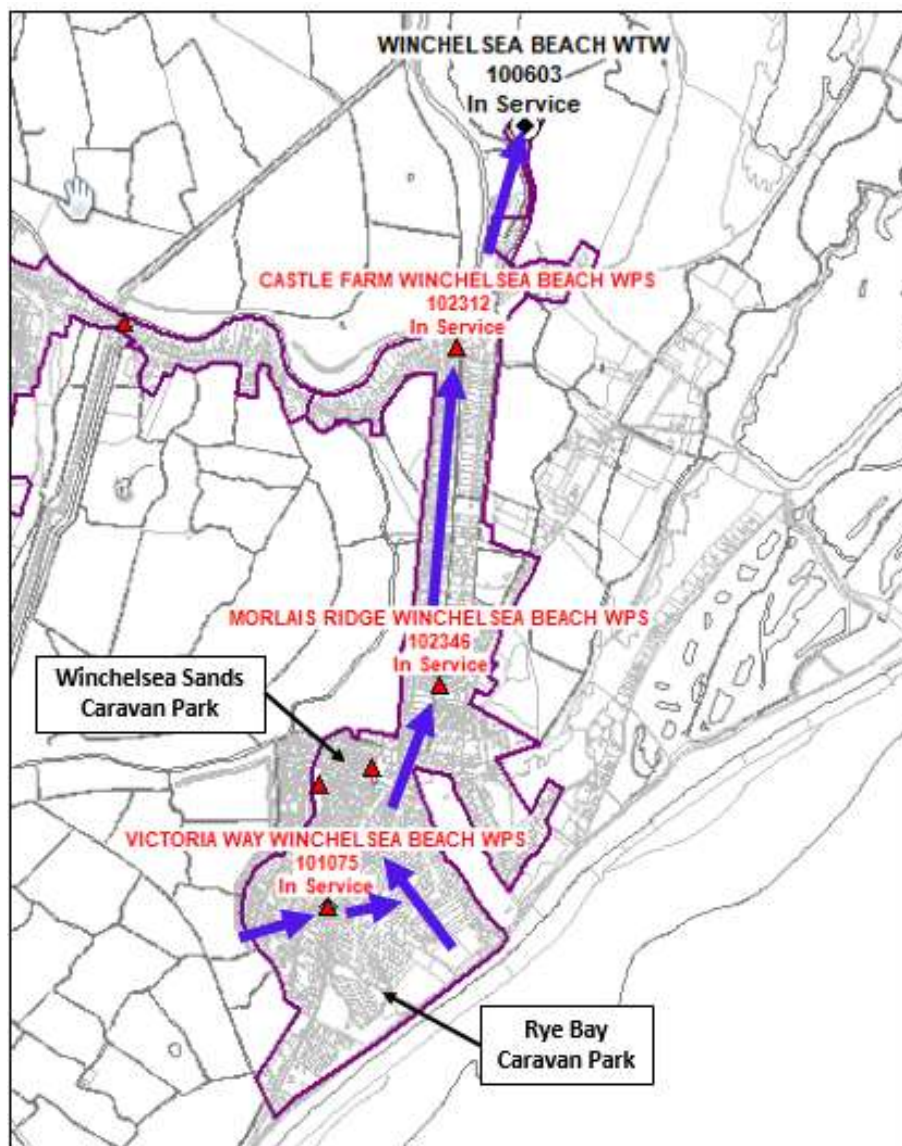
Reference Plan

Action	Km
Length Surveyed (CCTV)	4.36
Length Surveyed (Electroscan)	1.62
Length with no work required	1.20
Length Sealed	3.32
Length to be sealed	0.474
Manholes sealed	4
Manholes to be sealed	1

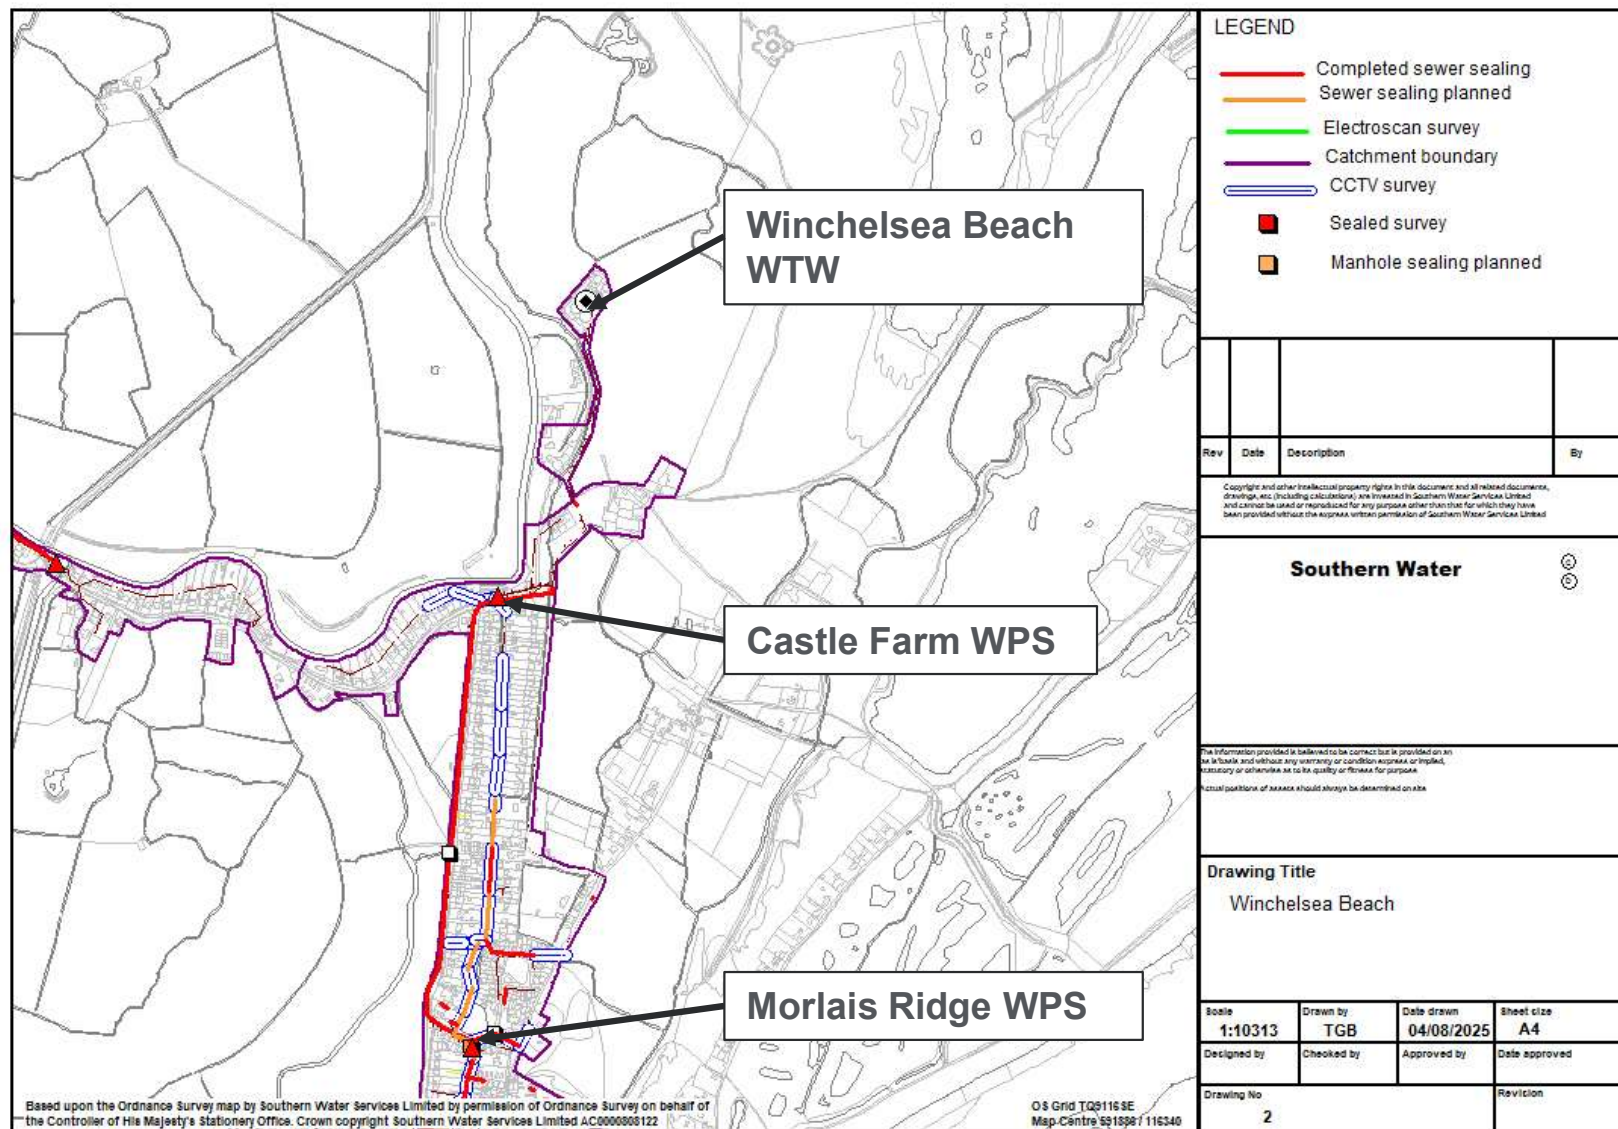
Detailed plan 1

Note – sewers shown as surveyed by cctv or Electroscan (green line) with no corresponding sealing work have been determined to not require rehabilitation. The use of storm harvester data will be used at some point in the future to target inspections and find infiltration

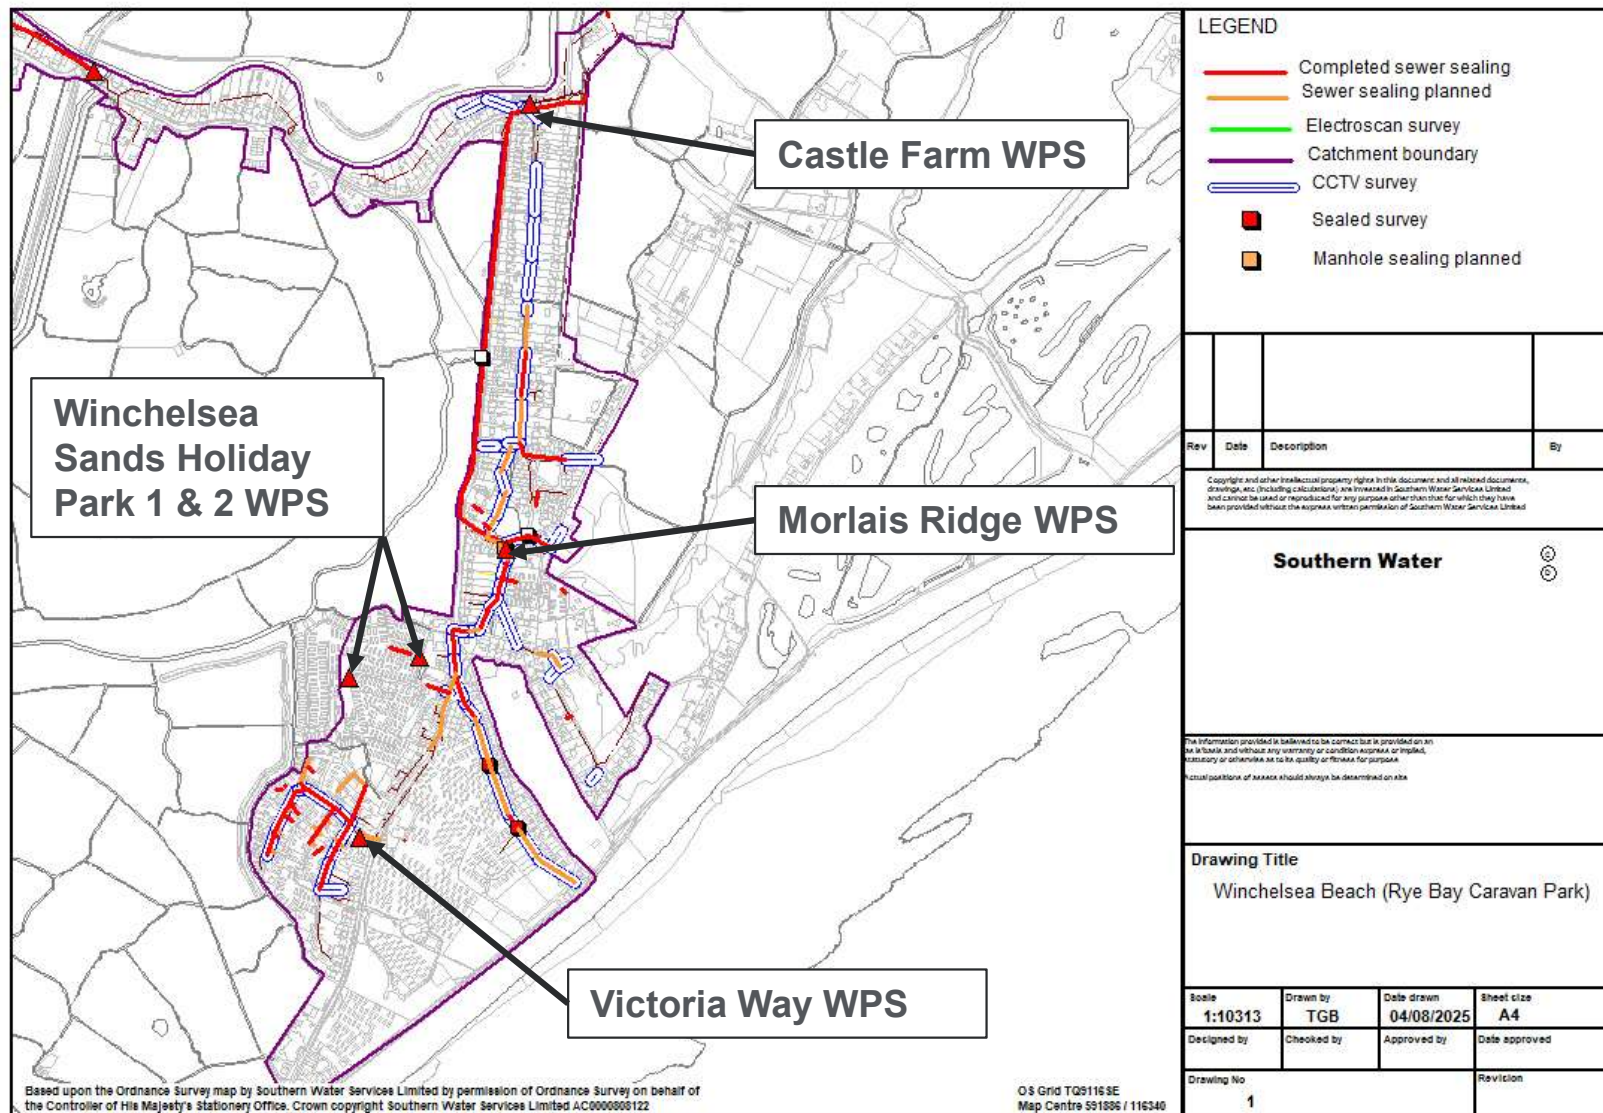
Detailed plan 2

Note – sewers shown as surveyed by cctv or Electroscan (green line) with no corresponding sealing work have been determined to not require rehabilitation. The use of storm harvester data will be used at some point in the future to target inspections and find infiltration
