Infiltration Reduction Plan

Hambledon

August 2025
Version 9

from
**Southern
Water**

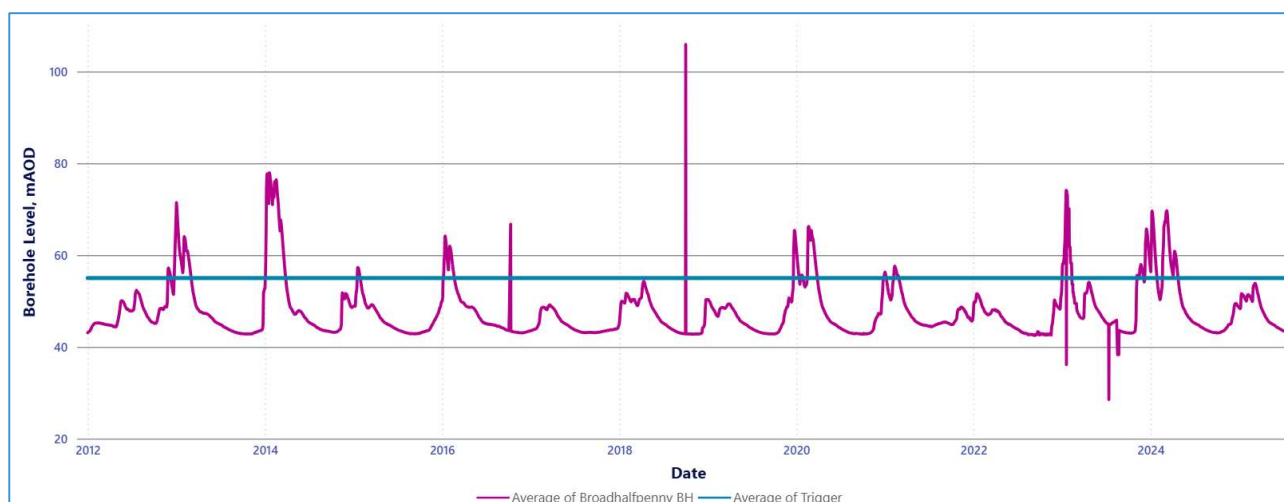
Figure 4.1 – Groundwater levels from 2012 to 2025 at Broadhalfpenny Down

Figure 4.1 illustrates groundwater levels in the period 2012 to 2025. Historic analysis showed that periods of high groundwater correspond well with periods of prolonged high wet well levels at Bury Lodge.

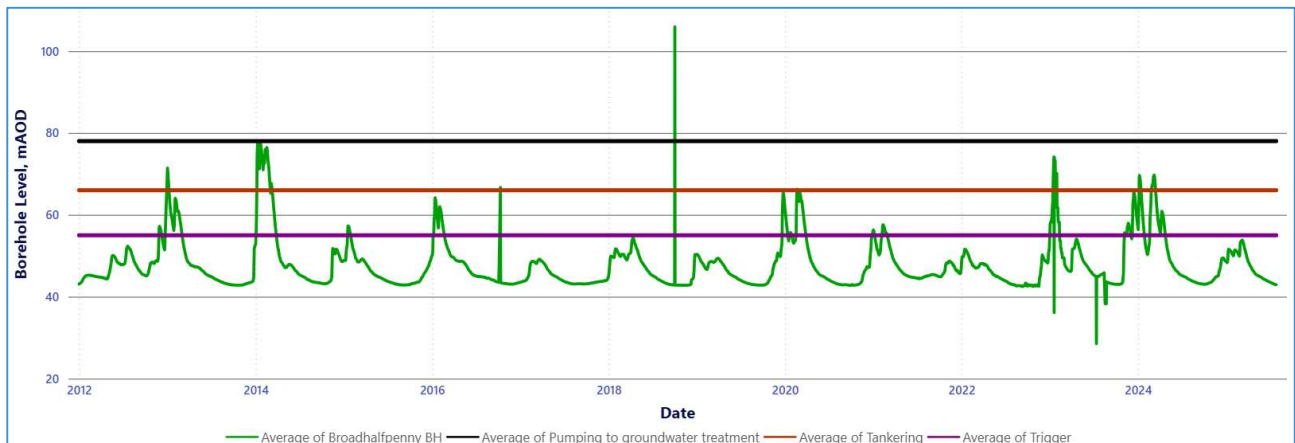
Figure 6.1 – Forecasting of Trigger Dates

The graph below, in Figure 6.1, is an example of those used for predicting the earliest, average, and latest dates for when the trigger levels are forecast to be breached. This graph shows groundwater levels and an indication of flows, with the Trigger Level shown by the horizontal purple line.
